Flood Control Project Maintenance**2012 Structure Summary Report****Overall Unit and Item Ratings****Lower San Joaquin Levee District****Ash Slough Drop Structure No. 1**

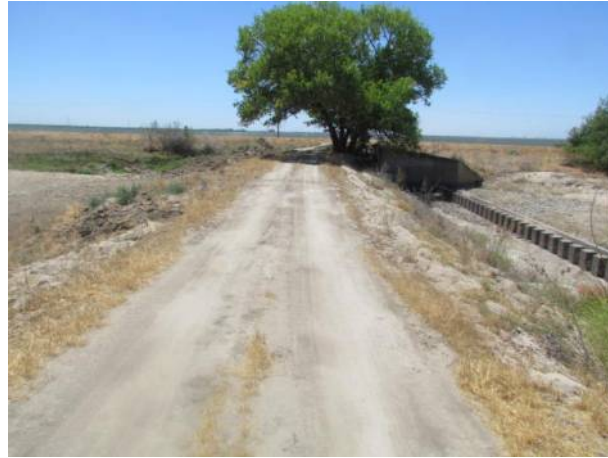
Levee Mile Report Line	6
Start Levee Mile	0.00
End Levee Mile	0.00
Location	
Category	Structures
Item	Encroachments
Looking east at sand dam on upstream side of drop structure # 4.	
richard_t_20120731_147.JPG

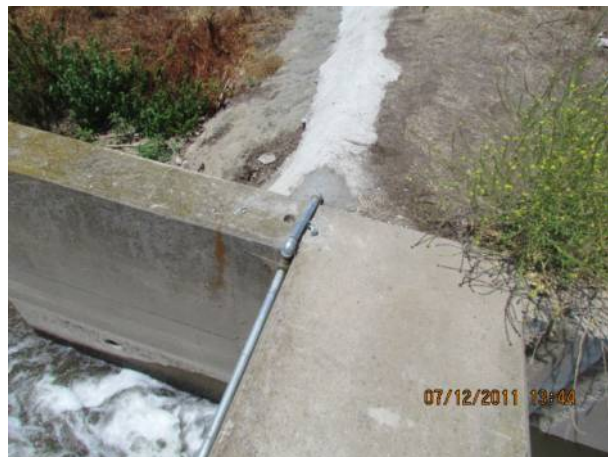
Levee Mile Report Line	6
Start Levee Mile	0.00
End Levee Mile	0.00
Location	
Category	Structures
Item	Encroachments
Looking at new electrical conduit on downstream side of structure.	
richard_t_20120627_019.jpg

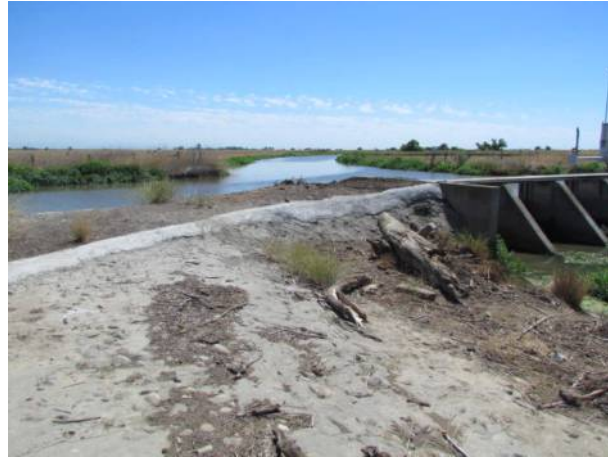
Levee Mile Report Line	6
Start Levee Mile	0.00
End Levee Mile	0.00
Location	
Category	Structures
Item	Encroachments
Looking east at electrical conduit trench on southside of structure.	
richard_t_20120730_085.JPG

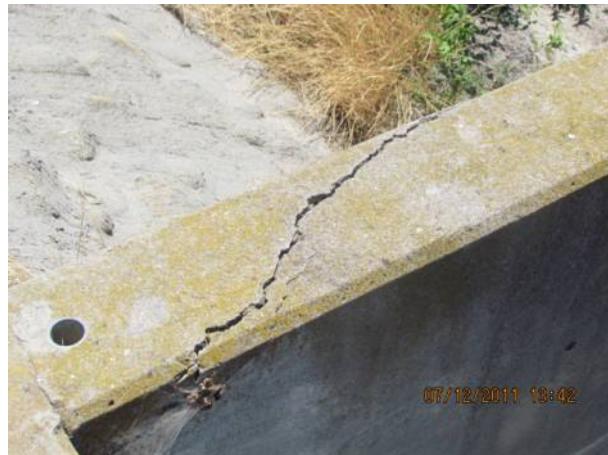
Levee Mile Report Line	15
Start Levee Mile	0.00
End Levee Mile	0.00
Location	
Category	Structures
Item	Concrete Surfaces
Looking at cracking on left wing wall.	
richard_t_20120627_021.jpg

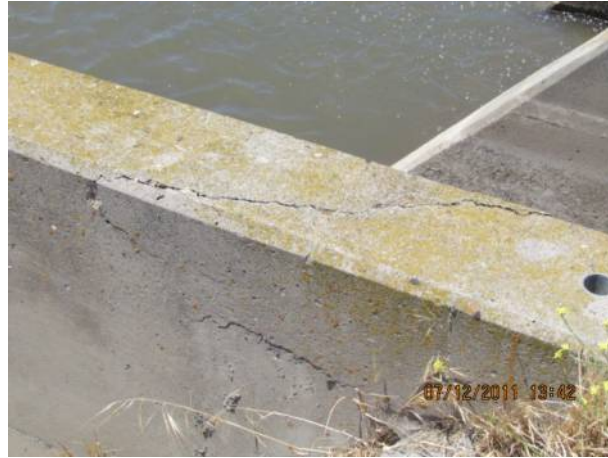
Levee Mile Report Line	15
Start Levee Mile	0.00
End Levee Mile	0.00
Location	
Category	Structures
Item	Concrete Surfaces
Looking northwest at cracking on left wing wall	
richard_t_20120627_022.jpg

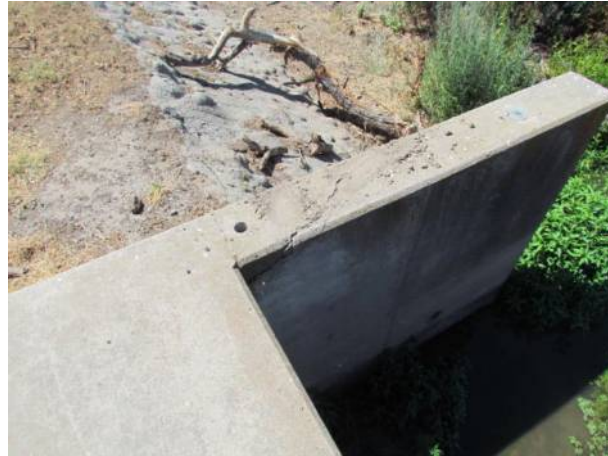
Levee Mile Report Line	15
Start Levee Mile	0.00
End Levee Mile	0.00
Location	
Category	Structures
Item	Concrete Surfaces
Looking at crack on left wing wall during 2012 inspection.	
richard_t_20120730_091.JPG

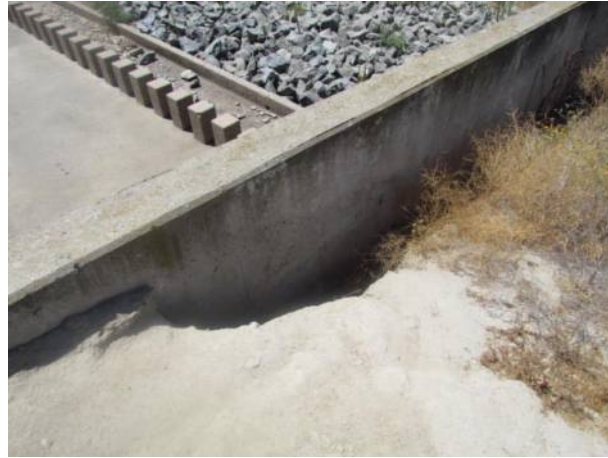
Levee Mile Report Line	4
Start Levee Mile	0.00
End Levee Mile	0.00
Location	
Category	Structures
Item	Erosion / Bank Caving
Looking at erosion/caving on right wing wall.	
richard_t_20120731_151.JPG

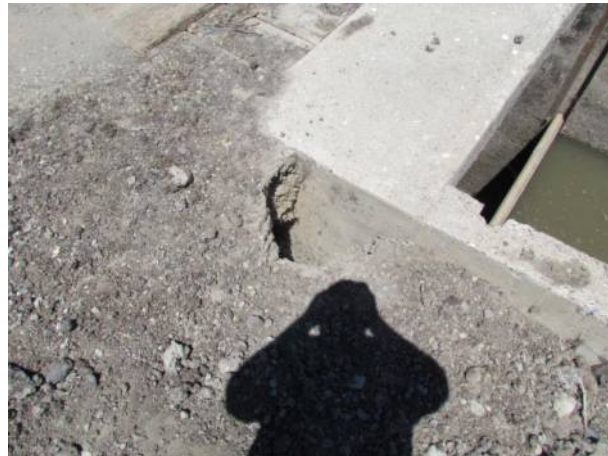
Levee Mile Report Line	4
Start Levee Mile	0.00
End Levee Mile	0.00
Location	
Category	Structures
Item	Erosion / Bank Caving
Looking at possible animal borrowing on right side of structure on upstream side.	
richard_t_20120730_108.JPG

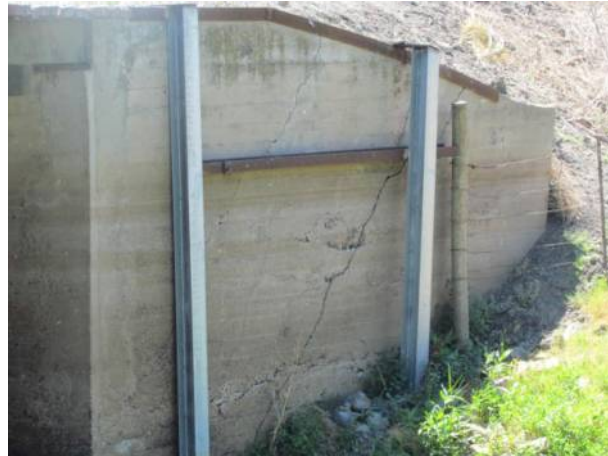
Levee Mile Report Line	16
Start Levee Mile	0.00
End Levee Mile	0.00
Location	
Category	Structures
Item	Concrete Tilting / Settlement
Looking at repaired right wing wall on downstream side of structure. Summer 2012	
richard_t_20120730_097.JPG

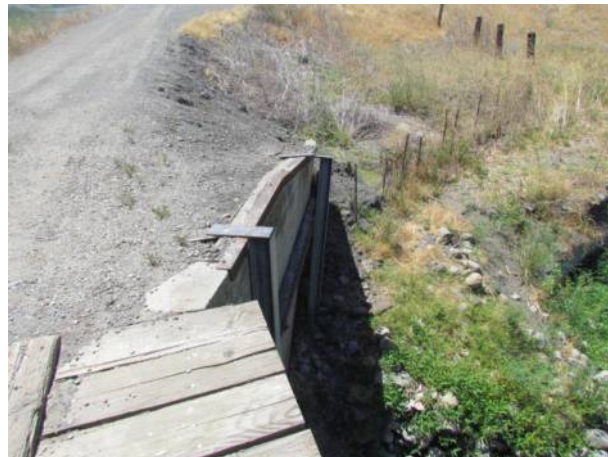
Levee Mile Report Line	16
Start Levee Mile	0.00
End Levee Mile	0.00
Location	
Category	Structures
Item	Concrete Tilting / Settlement
Looking west at brace on right wing wall on downstream side of structure. Summer 2012	
richard_t_20120730_098.JPG

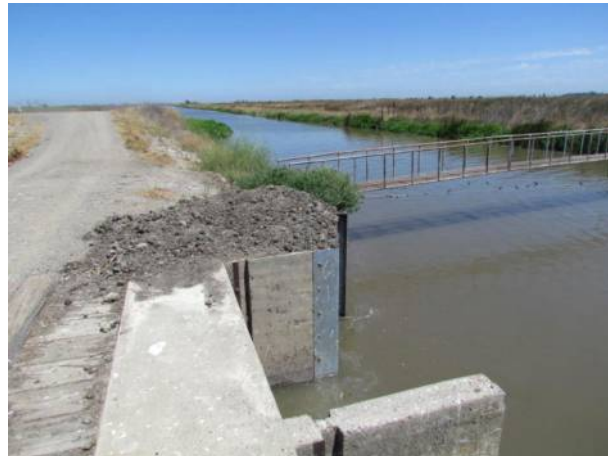
Levee Mile Report Line	22
Start Levee Mile	0.00
End Levee Mile	0.00
Location	
Category	Structures
Item	Monolith Joints
Looking at repaired right wing wall on upstream side of structure	
richard_t_20120730_102.JPG
